IMPROVEMENTS TO HIGHWAY GUARDRAIL ASSEMBLIES

ABSTRACT: Highway guardrail assemblies play an important role in enhancing the safety of motorists. It is essential that the blockouts are durable so that the guardrail assembly can function properly. The goal of this study was to explore the feasibility of using recycled CCA-treated wood to produce a composite blockout. Decommissioned blocks were chemically analysed and found to contain residual CCA that is consistent with over ten years of service. The used blocks were ground to particles, combined with polypropylene (plastic) and made into groups of composite blockouts with varying amounts of wood, plastic, block density, and resin. One yielded superior results: internal bond strength (744.66 KPa), modulus of rupture (17.49 MPa), modulus of elasticity (3.04GPa), linear expansion (1.605 cm.), and thickness swelling (12.6%). The finite element analysis revealed that a guardrail assembly comprised with wood/plastic blockouts should perform similar to one with solid wood blockouts.

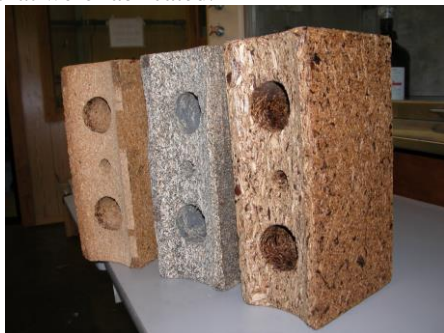
Figure 1: Guardrail block (Side view)

Three groups of composite blocks were produced: (1) wood 75%, polypropylene (PP) 25%, urea formaldehyde (UF) 8%, isocyanate (ISO) 1%, 53 pcf, (2) wood 75%, plastic 25%, UF 8%, ISO 1%, 43 PCF, and (3) wood 87.5, plastic 12.5%, UF 8%, ISO 1%, 43 PCF. Blocks were pressed at 204°C and 15 min press time. Six replications were made of each group. Samples were cut and tested in accordance with ASTM standards for IB, bending MOR, bending MOE, LE, and TS. Figure 1 illustrates some examples of the compression molded blocks that were fabricated.
