# IMPROVEMENTS TO HIGHWAY GUARDRAIL ASSEMBLIES

**ABSTRACT:** Highway guardrail assemblies play an important role in enhancing the safety of motorists. It is essential that the blockouts are durable so that the guardrail assembly can function properly. The goal of this study was to explore the feasibility of using recycled CCA-treated wood to produce a composite blockout. Decommissioned blocks were chemically analysed and found to contain residual CCA that is consistent with over ten years of service. The used blocks were ground to particles, combined with polypropylene (plastic) and made into groups of composite blockouts with varying amounts of wood, plastic, block density, and resin. One yielded superior results: internal bond strength (744.66 KPa), modulus of rupture (17.49 MPa), modulus of elasticity (3.04GPa), linear expansion (1.605 cm.), and thickness swelling (12.6%). The finite element analysis revealed that a guardrail assembly comprised with wood/plastic blockouts should perform similar to one with solid wood blockouts.

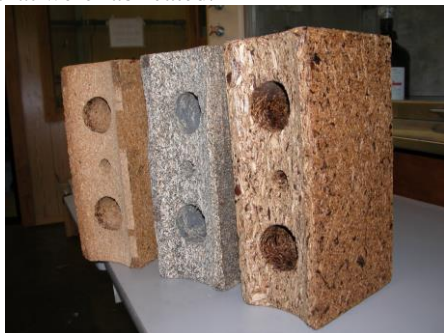
Three groups of composite blocks were produced: (1) wood 75%, polypropylene (PP) 25%, urea formaldehyde (UF) 8%, isocyanate (ISO) 1%, 53 pcf, (2) wood 75%, plastic 25%, UF 8%, ISO 1%, 43 PCF, and (3) wood 87.5, plastic 12.5%, UF 8%, ISO 1%, 43 PCF. Blocks were pressed at 204°C and 15 min press time. Six replications were made of each group. Samples were cut and tested in accordance with ASTM standards for IB, bending MOR, bending MOE, LE, and TS. Figure 1 illustrates some examples of the compression molded blocks that were fabricated.

Figure 1: Guardrail block (Side view)

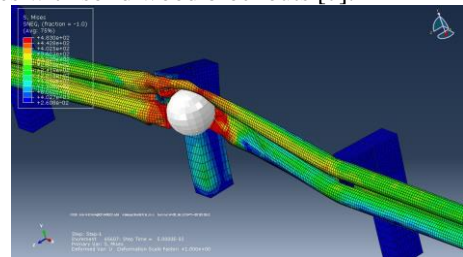
A finite element model of the deformation and energy conversion was established. During the simulation, the rigid ball bounced back with a lower speed after collision into the guardrail. In the collision process, the deformation energy was less than the initial kinetic energy, while the final deformation energy and the final kinetic energy were equal to the initial kinetic energy. In this analysis, the performance of a guardrail assembly featuring wood composite blockouts was no different than previous analyses by others of traditional assemblies with solid wood blockouts [7].

Figure 2: Simulation of impact stress
