# DECAY RESISTANCE OF OUT-OF-SERVICE UTILITY POLES AS RELATED TO THE DISTRIBUTION OF RESIDUAL CREOSOTE CONTENT

HAN ROLIADI  
CHUNG Y. HSE\*  
ELVIN T. CHOONG\*  
TODD F. SHUPE\*

Forest Prod. J. 50(11/12):64-68.

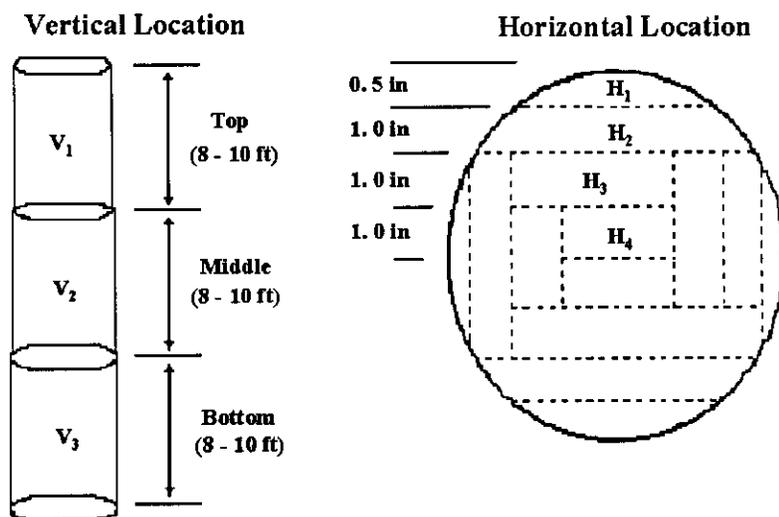
Figure 1. — Pattern of sawing procedures used for treated poles.

Weathered out-of-service SYP poles of two service duration groups (5 and 25 years of service duration) were selected. In addition, freshly treated poles of the same species were used for comparison purposes. Five different poles from each group were taken as replicates. These poles were obtained from Entergy Gulf States Utility Company and brought to Lee Memorial Forest near Bogalusa, La., for processing. All the poles were passed through a metal detector to remove metal objects. After metal removal, the poles were cut into 8- to 10-foot-long bolts. Three bolts (top, middle, and bottom) were selected from each pole. Each bolt was sawn into experimental specimens using a portable Wood-Mizer band sawmill at horizontal distances of 0.5, 1.5, 2.5, and 3.5 inches from the pole surface, respectively. Samples were taken and appropriately labeled from these sampling distances (Fig. 1). During sawing, sawdust samples obtained from various vertical and horizontal locations in the poles were

As described in the procedure for residual creosote distribution, visually defect-free samples were obtained from lumber at several vertical and horizontal locations in the poles. The samples were further sawn into blocks measuring 0.75 in.<sup>3</sup> They were stored in an environmental chamber at 80°F and 70 percent relative humidity (RH) for 24 hours until they reached equilibrium moisture content. Decay resistance was performed by the soil-block method, using a sandy loam soil with a water-holding capacity of 22 to 25 percent, in accordance with AWWA Standard M10-77 (3). Block samples were subjected to decay with the fungus *Neolentinus lepideus* Fr., which was obtained from the American Type Cultural Collection with specification No. 12653 (Madison 535). *Neolentinus lepideus* was used because it is creosote tolerant (7). For comparison purposes, 20 blocks of reference untreated SYP were also prepared. After air-drying and weighing, they were conditioned and subjected to decay in the same manner as treated test samples. SYP strips measuring 0.125 by 0.125 by 1.275 inches with the grain parallel to the long dimensions were used for each block. The bottles and feeder strips were sterilized using steam from an autoclave. Each of the strips was placed inside a bottle, containing the sandy loam soil, and then inoculated with fungus. The inoculated bottles were incubated in a conditioned room at 80°F and 70 percent RH for 3 weeks until the feeder strips were covered with mycelium. Test

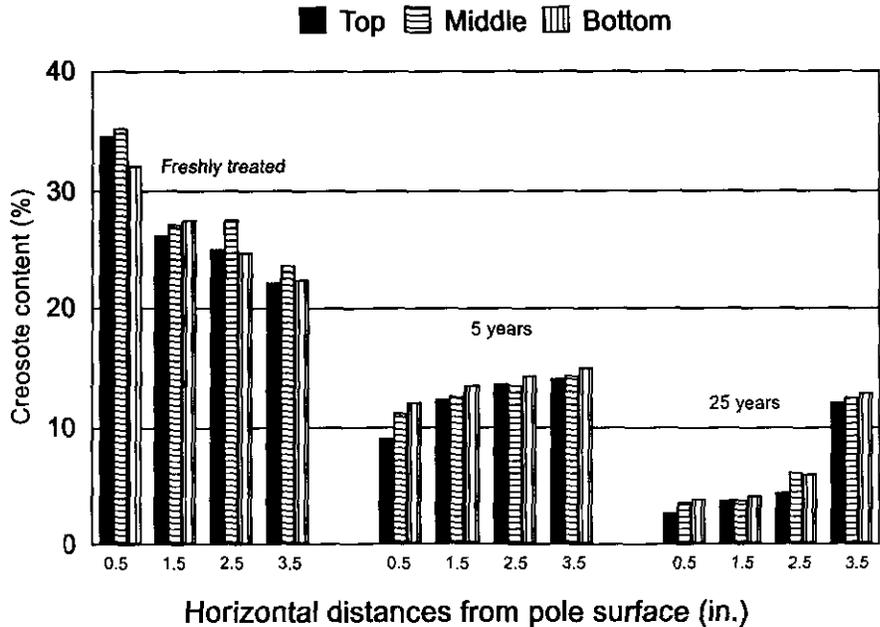
Figure 2. — Distribution of creosote content (%) in treated poles.

The analysis of variance reveals that the effects of main sources of variances (service duration, vertical locations, and horizontal locations) and the interaction of these three variables were significant (Table 1). The significant interaction shows that at a given pole service duration and vertical location, the creosote content had specific patterns of changes with respect to horizontal location (Figs. 2 and 3). Creosote content in freshly treated poles was much higher than in weathered poles. In weathered poles with 5-year service duration, the residual creosote content tended to increase horizontally from the surface to the pith, and vertically from the upper to the bottom portions. To the contrary, the horizontal trend in freshly treated poles was the inverse of weathered poles; the creosote content was highest in the outer portion and lowest in the interior. The vertical trend, however, showed no significant changes.

The decreasing trend in residual creosote from the pith to the surface of 5- and 25-year poles is mainly due to the effect of bleeding and leaching of creosote during service (6,9,14,15,17). In long-term weathering, the surface of poles was more exposed to high temperature than the interior, causing the evaporation mostly of low-molecular-weight (more volatile) fractions of the creosote. As a result, outward movement of creosote occurred due to the pressure gradient between the surface and the interior of the poles. Higher residual creosote content inside the weathered poles beyond 2.5 inches distance from the surface could

In freshly treated poles, weight loss in the outer portion was negligible (Fig. 4) since the creosote content near the surface was high (Figs. 2 and 3). The weight loss increased slightly toward the pith due to the inward gradual decrease in creosote content. With respect to vertical location, the weight loss in freshly treated poles showed no significant changes. In 5- and 25-year poles, the weight loss was greater in the upper and outer portions than in the bottom and interior, while the residual creosote content in the same locations decreased horizontally outward and upward. This indicates that the loss of creosote in the outer and upper portions of weathered poles rendered the poles less effective in inhibiting the decaying activities of the fungus.

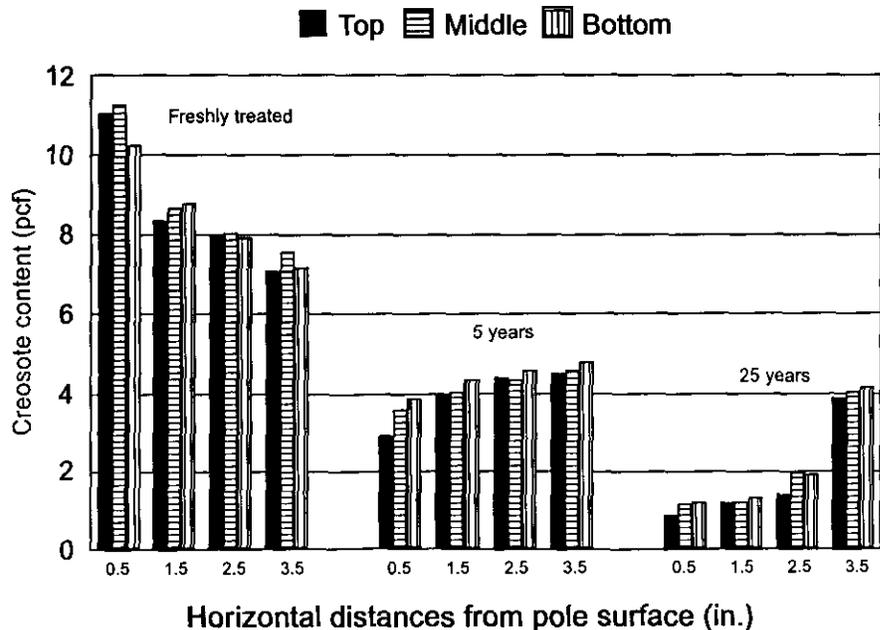
Figure 3. — Distribution of creosote content (pcf) in poles.

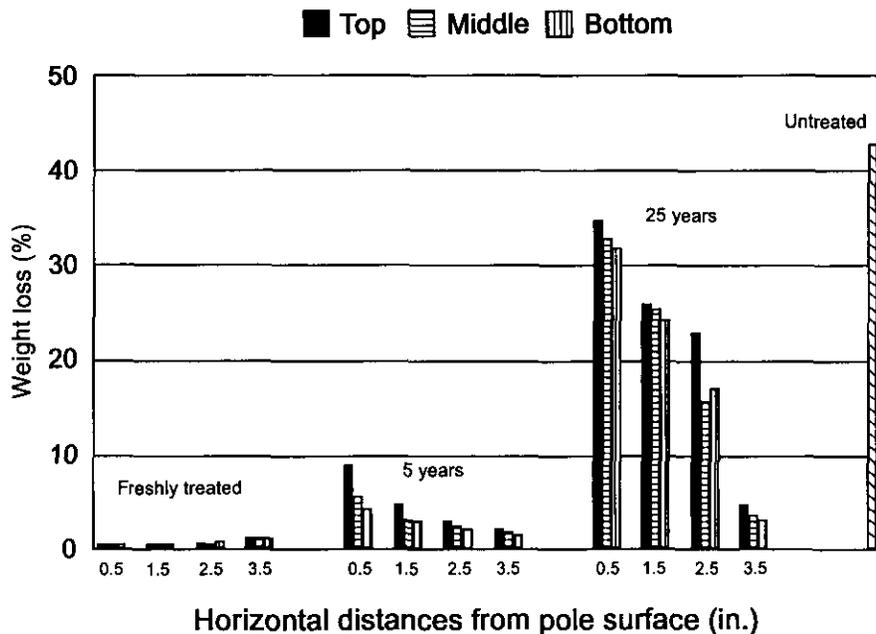
Figure 4. — Weight loss with respect to vertical and horizontal locations in treated poles.

The analysis of variance of weight loss of treated poles (Table 1) shows that the effects of all sources of variation (i.e., service duration and vertical and horizontal locations) were significant. Poles with longer service duration had higher weight loss, indicating more intensive decay (Fig. 4). Weathering, which caused a reduction in creosote content (Figs. 2 and 3), made the exposed part of the wood poles less protected, and therefore, more vulnerable to biodegradation by fungi. In untreated SYP, the weight loss was much higher than in all the treated poles.

When pole averages are considered, the weight loss in freshly treated poles at 0.5 and 3.5 inches from the pole surface was 0.6 and 1.3 percent, respectively. For weathered poles, the weight loss at the corresponding horizontal distances was 6.4 and 1.9 percent in 5-year poles and 32.1 and 4.2 percent in 25-year poles, respectively. For untreated SYP, the weight loss was the greatest (42.9%). It is apparent that the decay resistance of 5-year poles was still high and closer to freshly treated poles; while low decay resistance in the outer portions of 25-year poles was approaching that of untreated SYP.

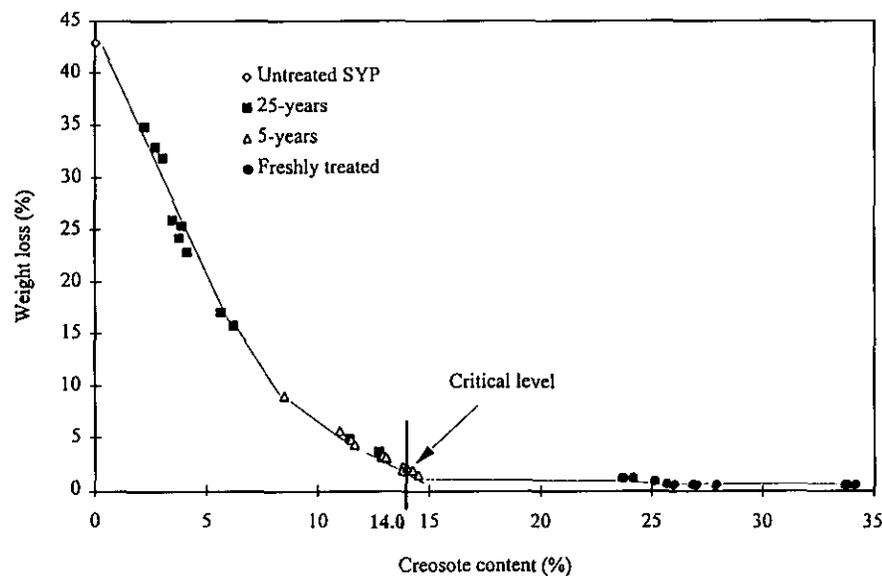
Figure 5. — Relationship between creosote content and weight loss.

It is interesting to note that the fungus-induced weight loss was negligible at creosote contents above the 14 percent level (Fig. 5). Weight loss increased dramatically with the reduction in creosote content starting from this critical level, indicating that at low creosote contents there was much greater activity by the fungus. For example, the weight loss in the outer portions of 25-year poles ranged from 31.9 to 34.8 percent (Fig. 4), while the creosote content in the corresponding portions ranged from 2.7 to 2.8 percent. Conversely, weight loss in the inner portions of these poles was much lower (3.2% to 5.0%) since the creosote content was still close to the 14 percent critical level (11.4% to 12.9%). This might be linked to the reduction of creosote content in the outer portion, which was accompanied by some loss of its more volatile (i.e., low-molecular-weight) fractions, as described in the distribution of residual creosote inside the weathered poles.

In weathered poles, the residual creosote content at 14 percent was regarded as the critical level. Below this level, the decay resistance decreased considerably.
